WATER LICENCE INSPECTION FORM

On September 7th an inspection of CNRDC's Ferguson Lake Project was completed by Crown-Indigenous Relations and Northern Affairs Canada ('CIRNAC')s, Resource Management Officer, Christine Wilson ('Inspector'). The inspection was conducted to ensure compliance with applicable terms and conditions of water licence, no. 2BE-FER1823.

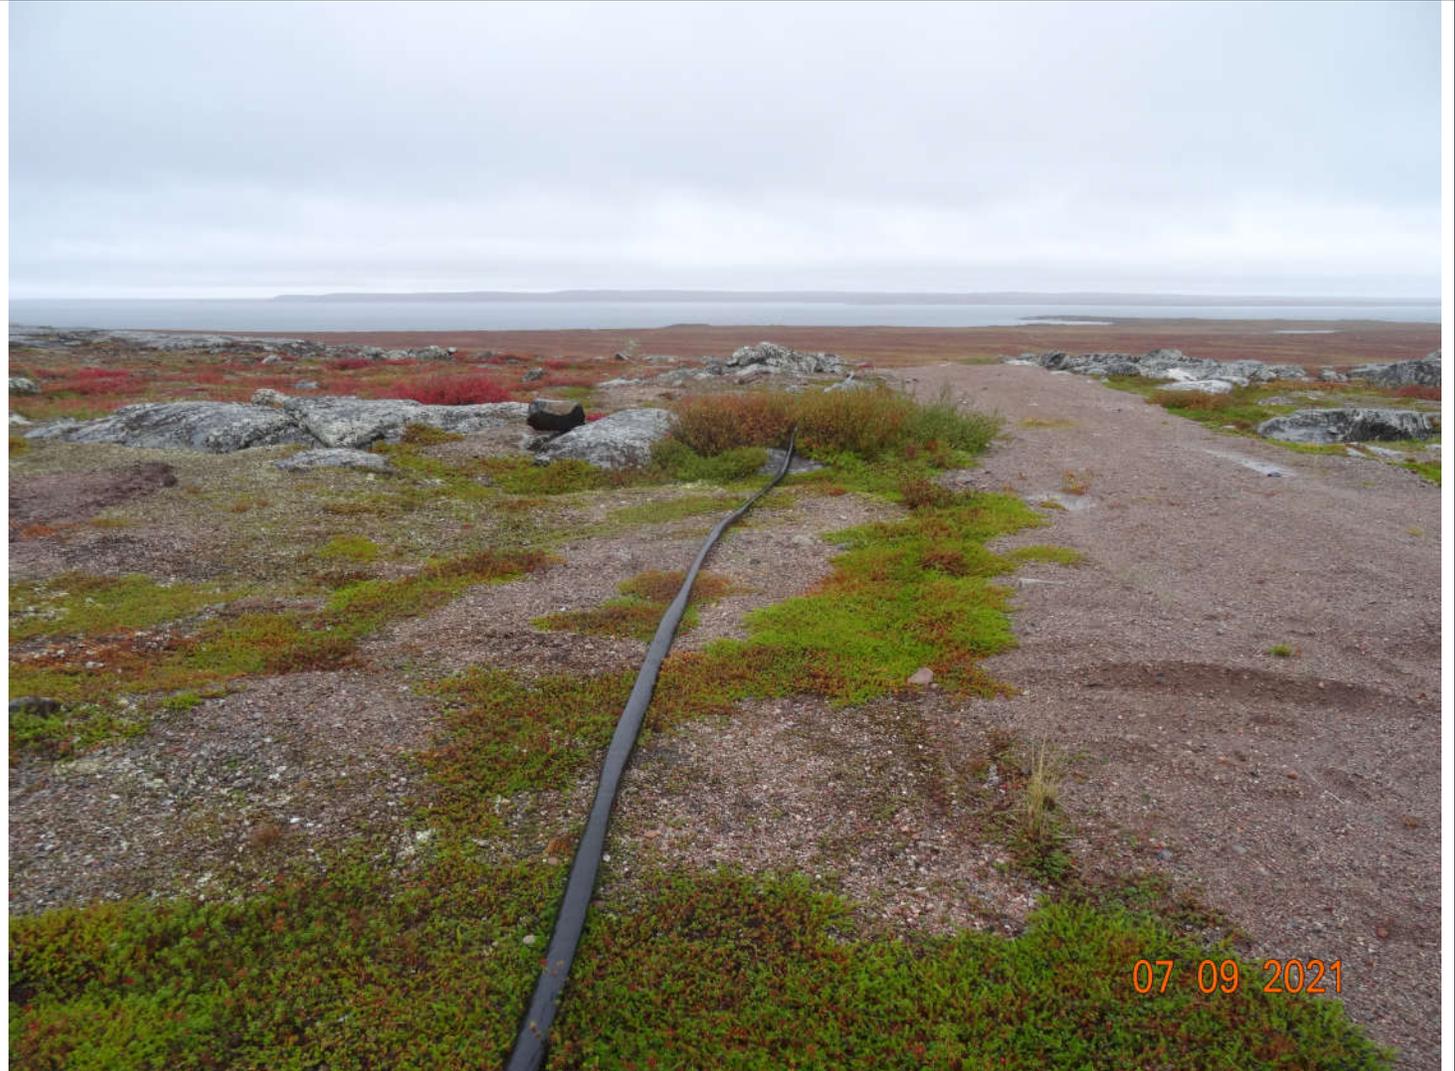
Date:	Authorization Number:	Camera/Model:	Inspector
September 7th, 2021	2BE-FER1823	Sony DSC-HX50V Cyber shot	RMO Wilson
Photo No.	Lat/Long (DD.MM.SS.SS, NAD83)		
Photo 1	N62° 53' 36.11", W96° 54' 19.93"

1. Fresh water is drawn from Ferguson Lake through a conveyance line (photo 1) to the camp and stored in bulk tanks (photo 2) for domestic use. The bulk tanks are refilled weekly and appear to store approximately 25m³.
2. The fresh water intake hose is fitted with a screened nozzle (photo 3). Water is pumped at a rate of 15 gallons per minute.
3. The fresh water bulk tanks are measured, and the total water use is recorded daily (photo 4). The total water use records are available for review (photo 5) pursuant to PART J item 1.
4. The allotted volume for domestic water use is 5m³ per day. On average approximately 2m³ of water is used per day when measured from the bulk tanks. All water use must be measured daily directly from the source this includes resupply of the tanks and recirculation a the drills.

Description:
Conveyance line from Ferguson lake to camp

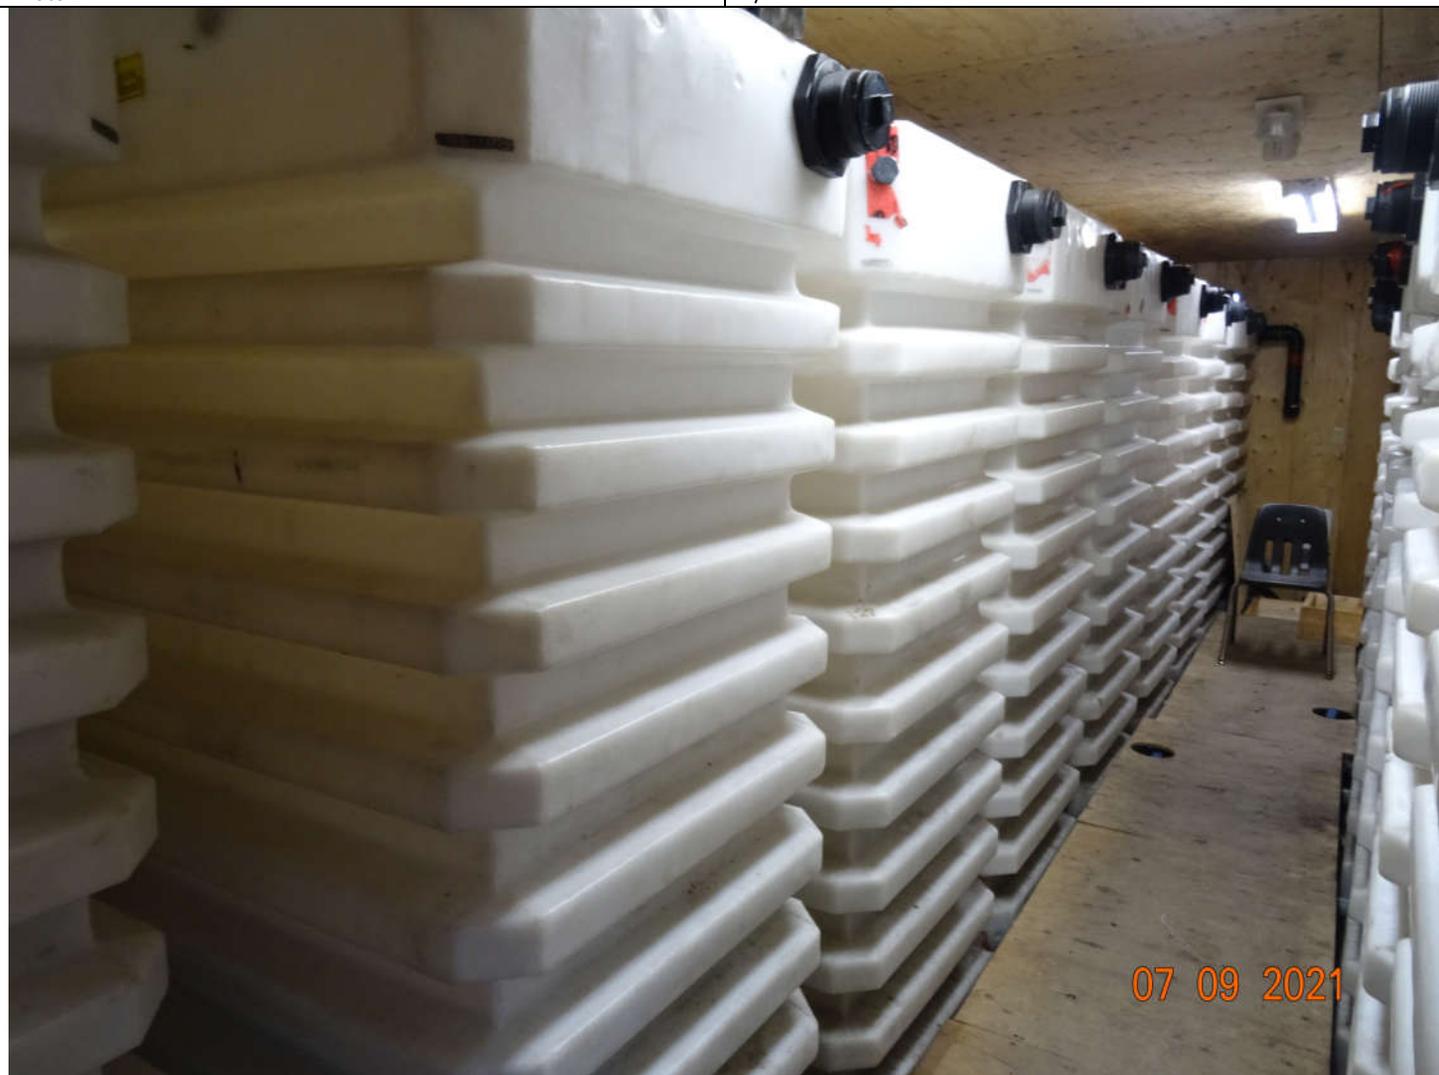
Photo 2

Fresh Water Storage Tanks

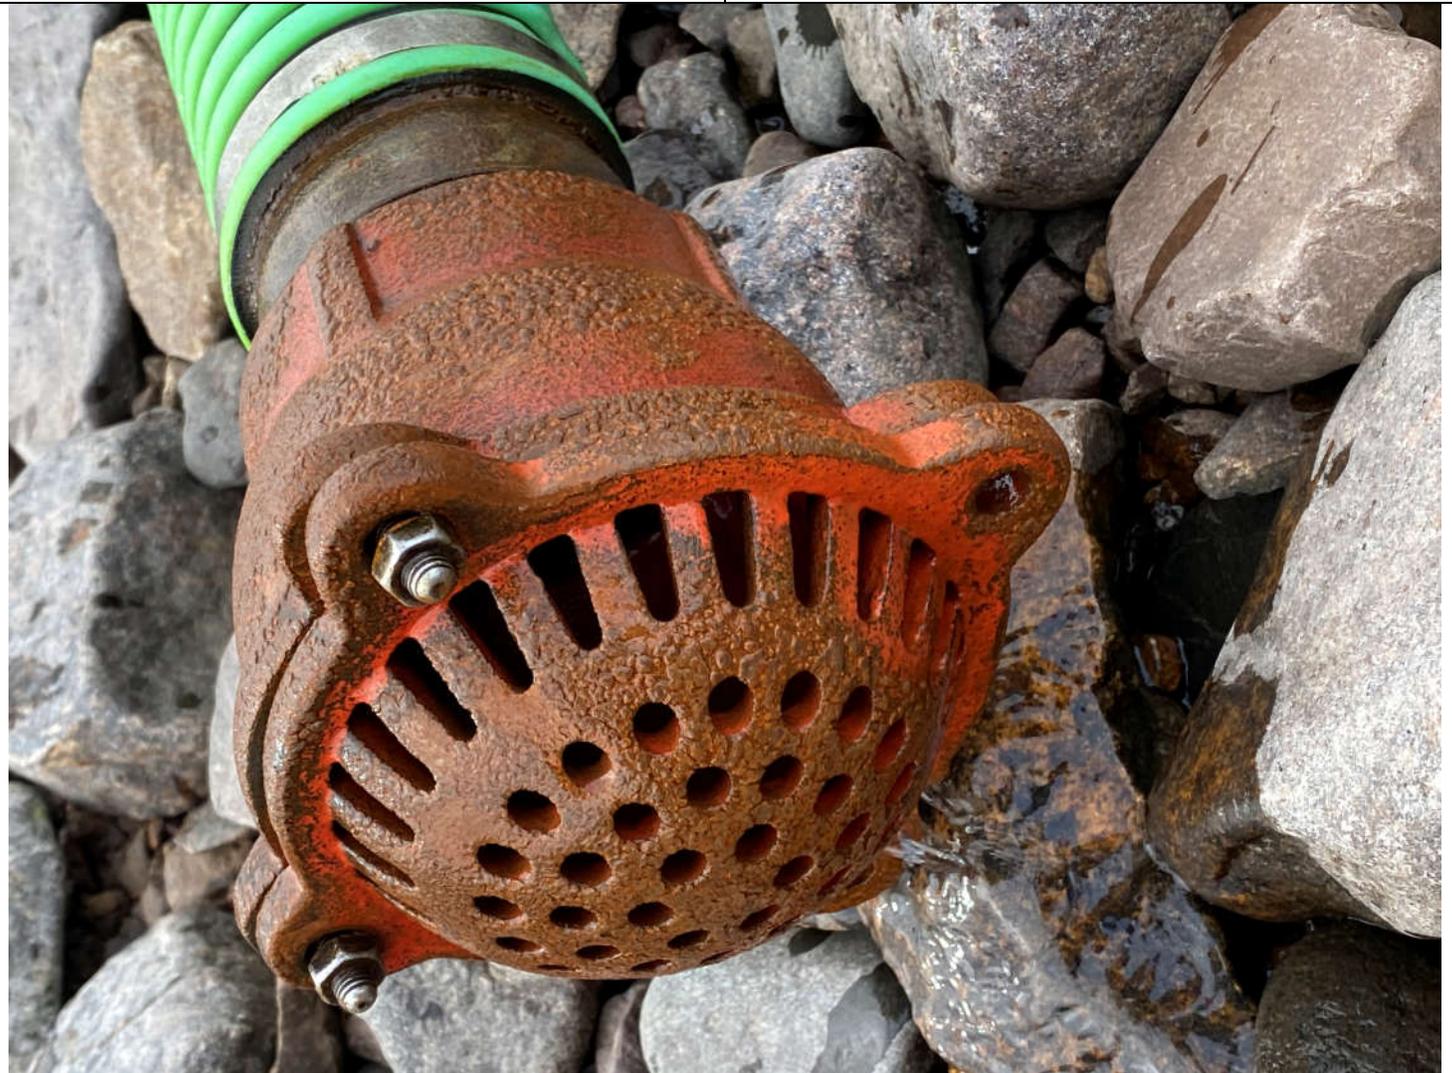
Photo 3

Picture provided by T.Boyd- Fresh water intake hose and nozzle

4. The camp water pump when filling up the tanks drew water at a rate of 15 gal per minute. Attached is a photo of the water intake nozzle for the water hose taken at Ferguson Lake. The nozzle has a barrier with slits which is placed into the lake.

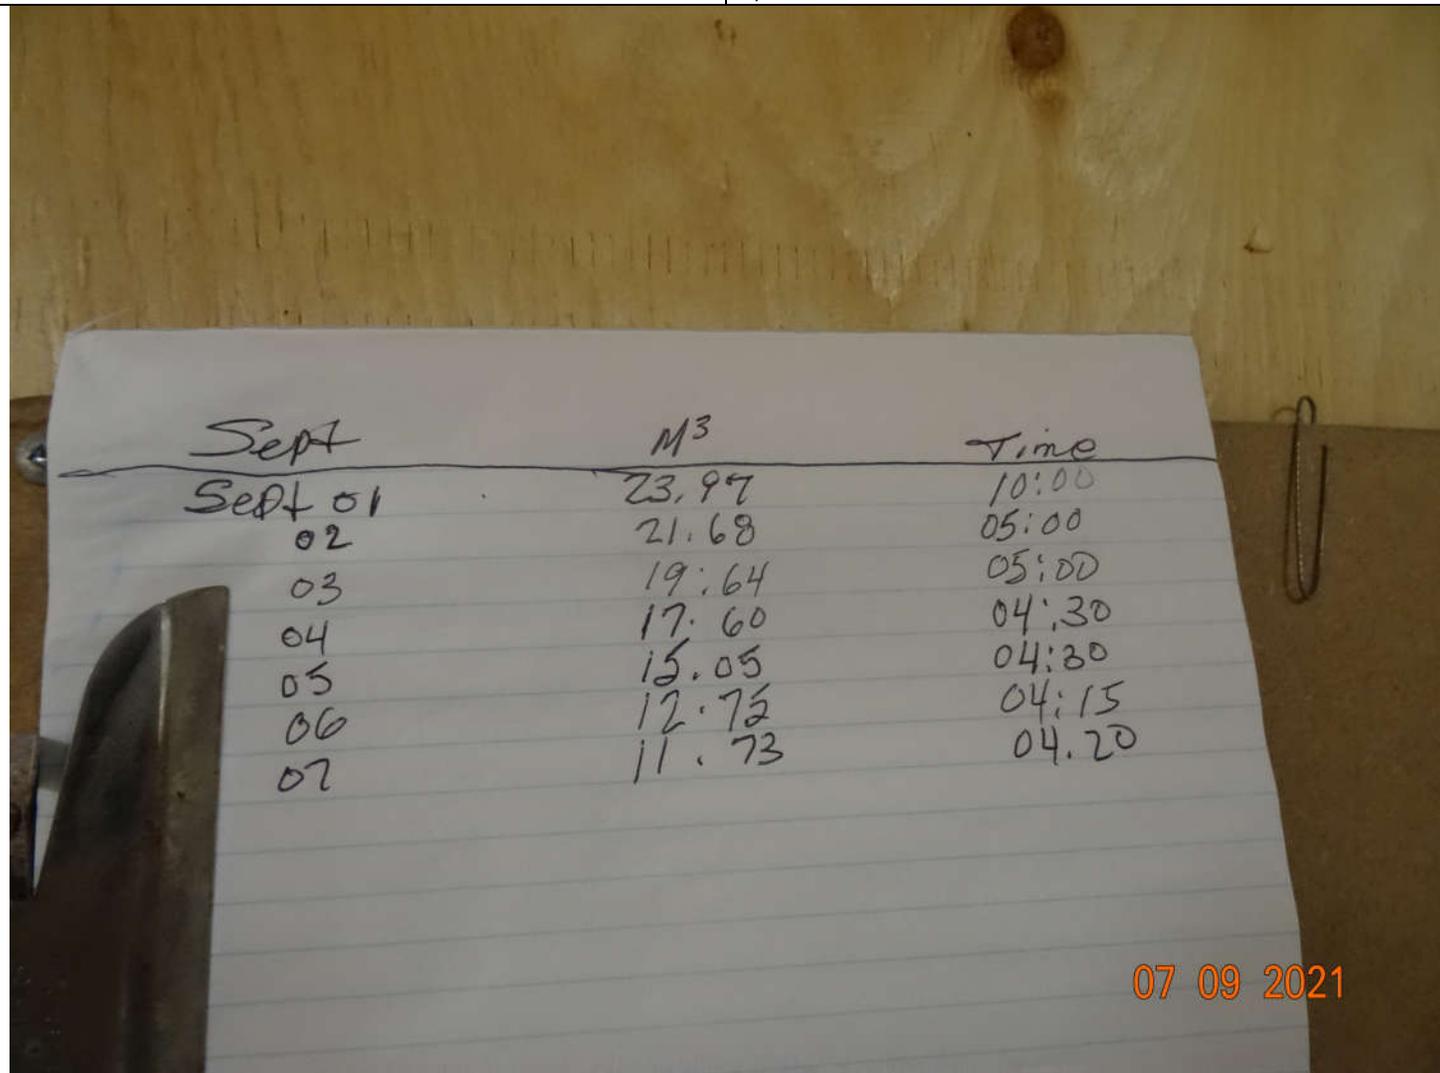
Photo 4

September water use records

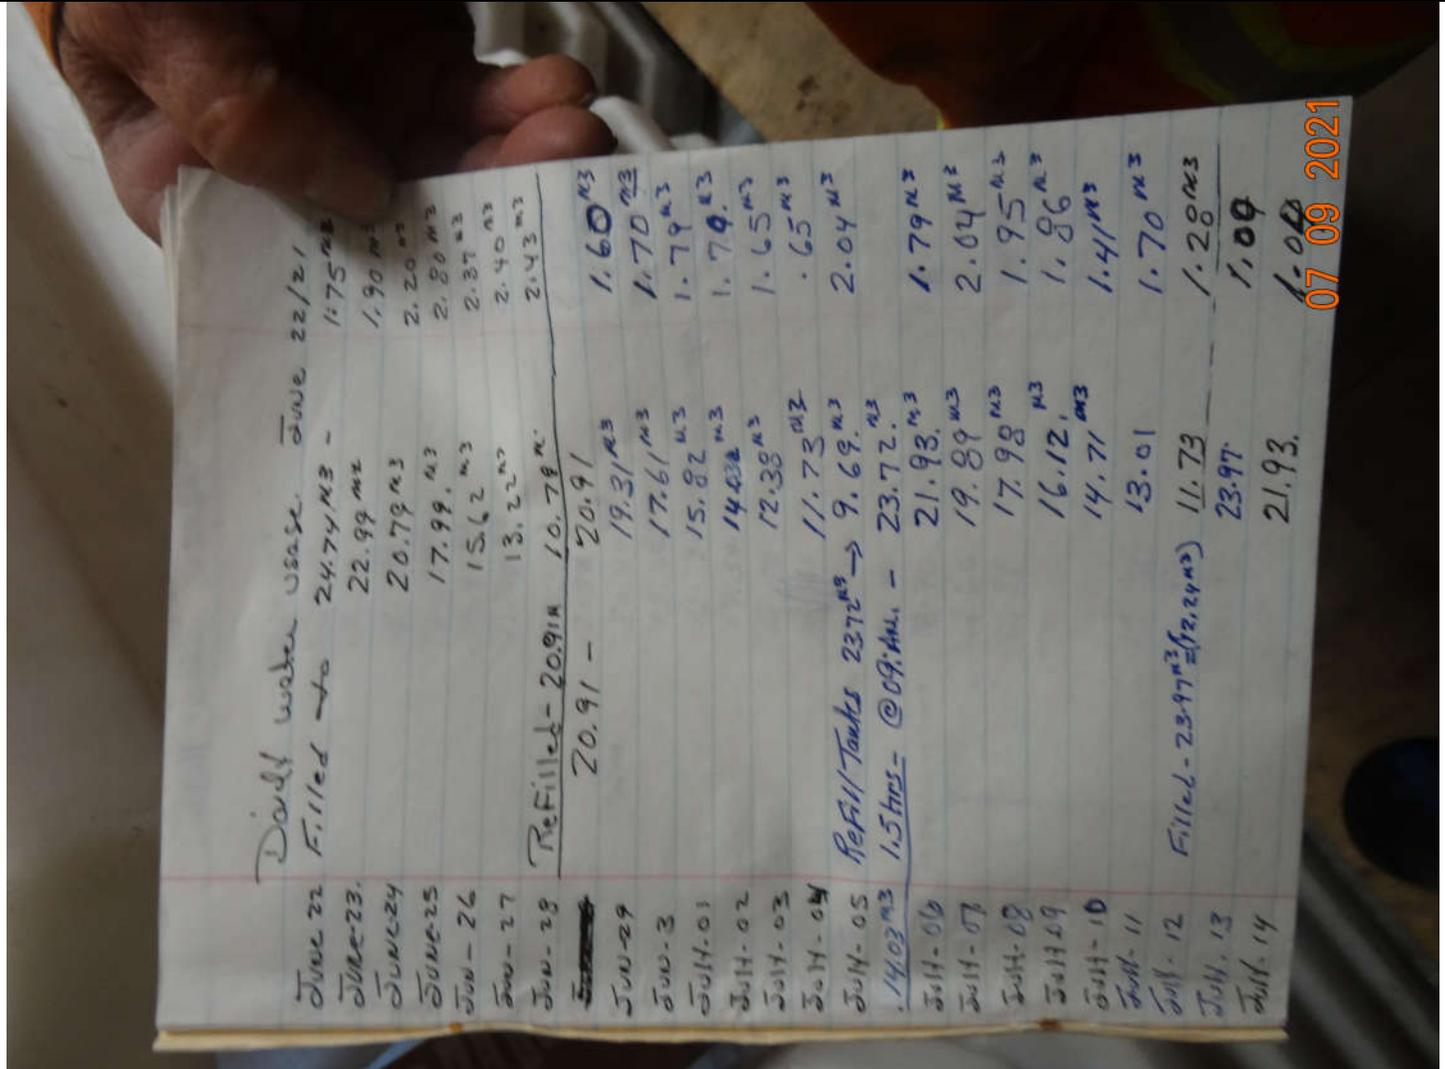
Photo 5

Total domestic water use record for 2021

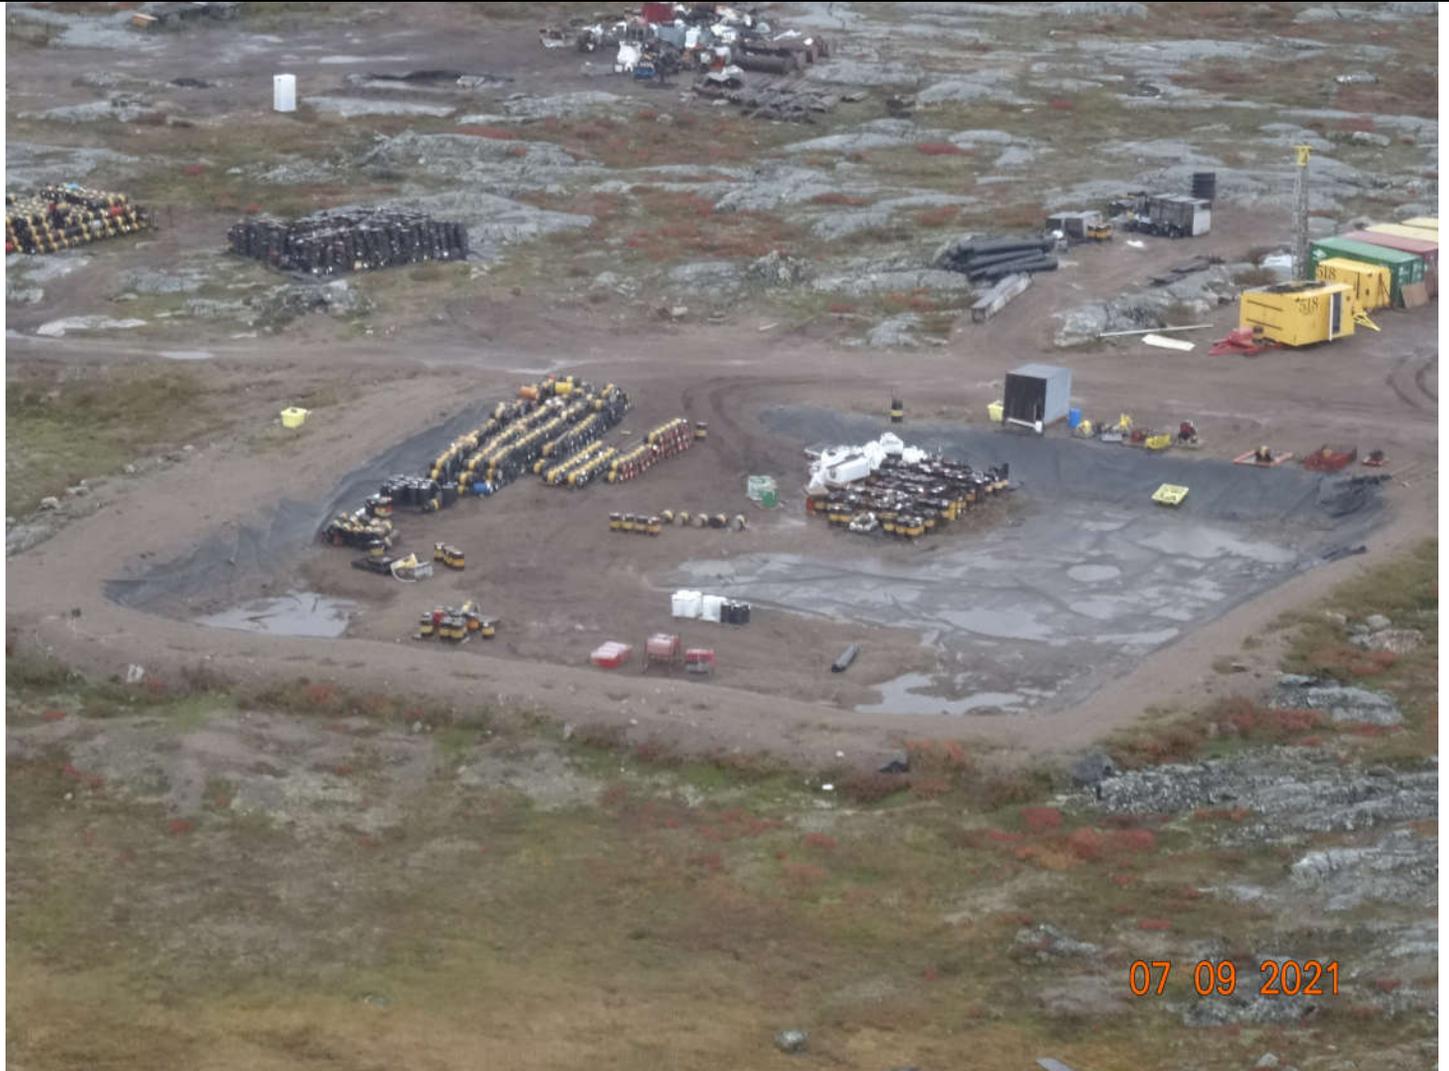
Photo 6

- 6. Bulk metal, hazardous waste and other materials are being organized and prepared for back haul in accordance with PART I item 4 (photo 6). A lot of work has taken place over the 2020-2021 season to progressively reclaim the historical waste that was left by the previous operator.
- 7. The Fuel Containment Area was discharged prior to the inspection (photo 6). The proponent made an assessment of the effluent prior to discharge but failed to meet the minimum requirements of PART D item 11 and PART J item 5.

Amalgamated waste in Fuel Containment Area and water inside the berm.

- The Proponent will review the minimum requirements for measuring and recording freshwater and provide a summary of the method to be implemented during the 2022 field season.
- The Proponent will contact the Nunavut Water Board to address the concern noted in observation 4 of this report.
- The Proponent will review PART D item 11 and PART D item 12 and provide a summary of how they will meet them moving forward.
