WATER LICENCE INSPECTION FORM

Licensee		Licensee Representative	
Dept. of Geography and Planning, Queen’s University		Scott Lamoureux	
Licence No. / Expiry		Representative’s Title	
8WLC-CBA1920			
Land / Other Authorizations		Land / Other Authorizations	
N2017N0001			
Date of Inspection		Inspector	
July 7, 2019		Joseph Monteith, Erik Allain, and Jeremy Fraser	
Activities Inspected			
<input type="checkbox"/> Camp	<input type="checkbox"/> Drilling	<input type="checkbox"/> Mining	<input type="checkbox"/> Construction
<input type="checkbox"/> Roads/Hauling	<input checked="" type="checkbox"/> Other: Water Treatment Facility, Waste Water Utilidor Hazardous Waste Facility	<input type="checkbox"/> Reclamation	<input type="checkbox"/> Fuel Storage

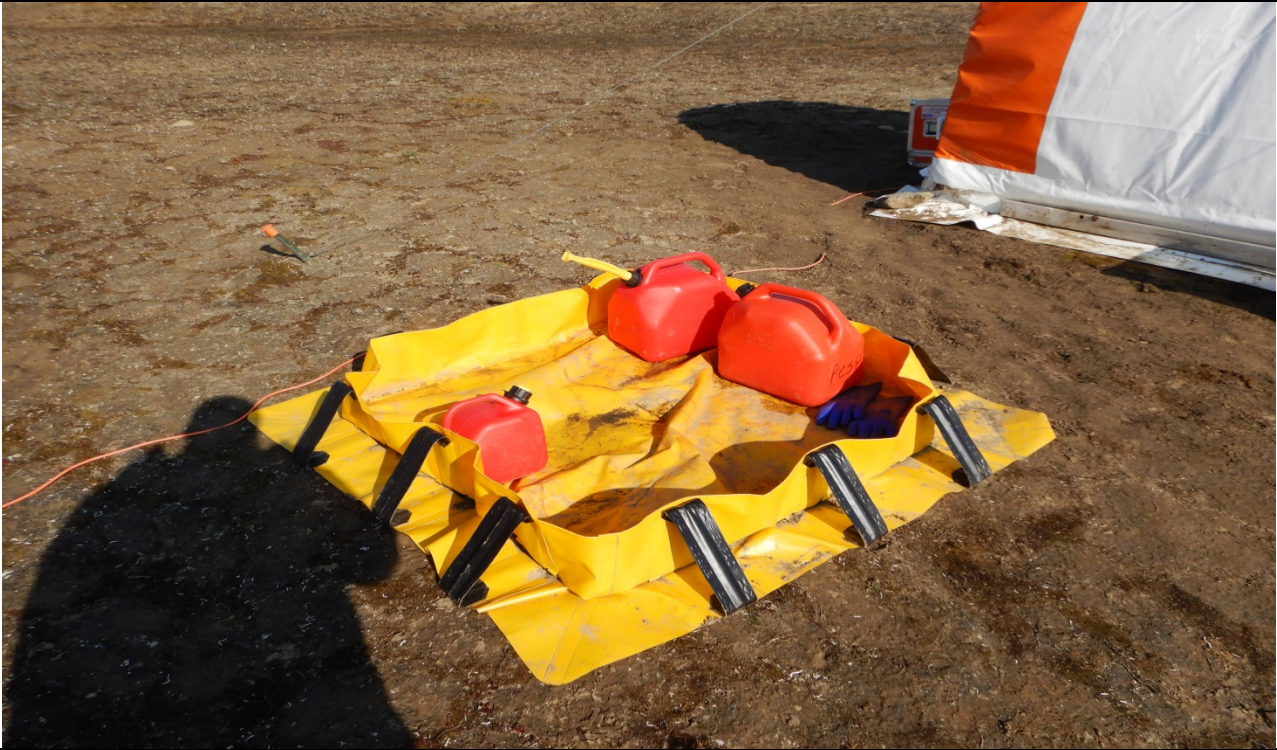
Photo 5

7. 2 fuel caches observed on site (photo 5&6).
8. Total count of fuel was 1 drum of gasoline, 5 jerry cans of gasoline, and 13 cylinders of propane.

Description: 2 5 gallon jerry cans, and a 2 litre jerry can. Rubber gloves in secondary containment berm.

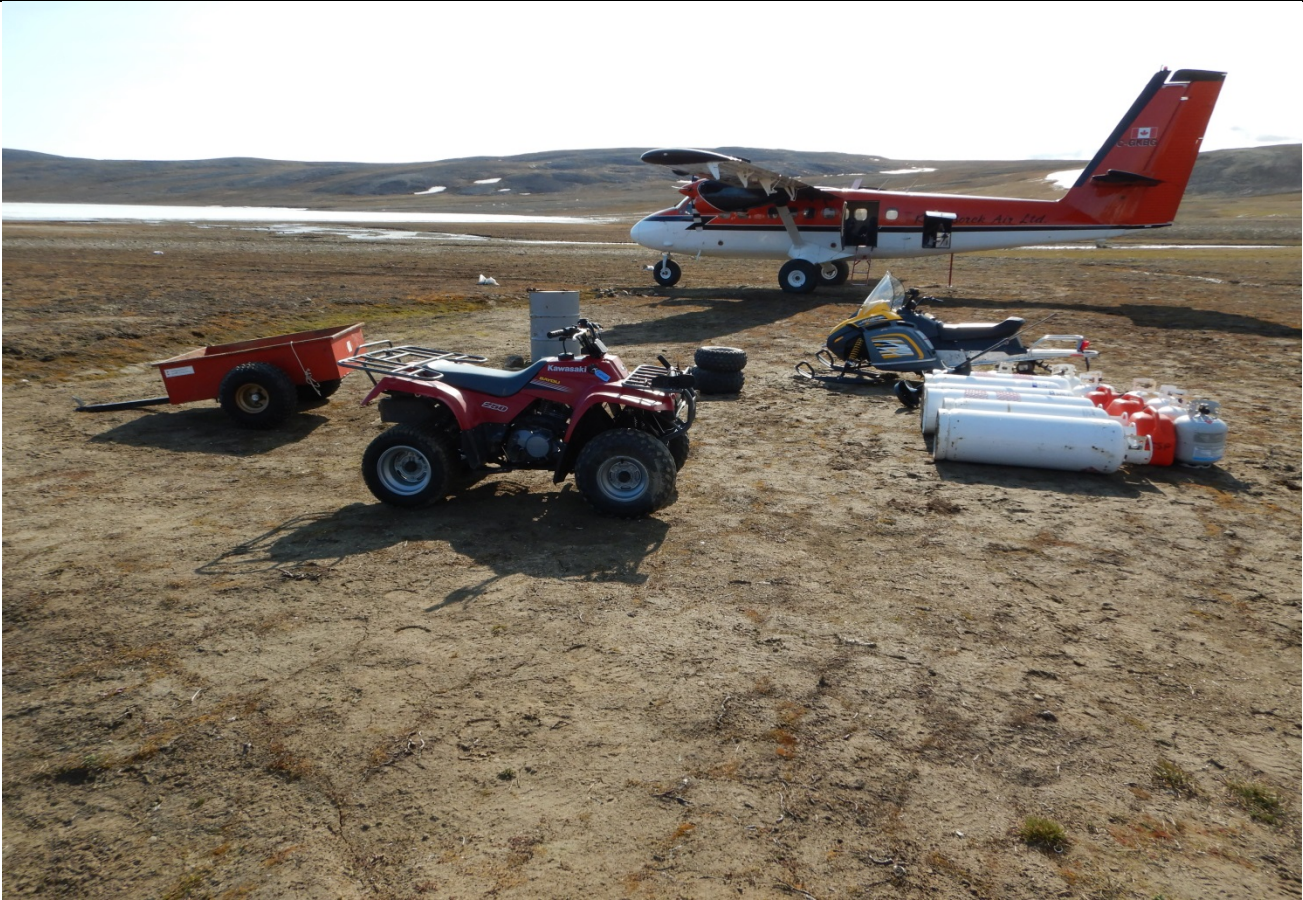
Photo 6

Description: fuel cache consisted of 5 jerry cans of gasoline, 10 various sizes of propane. No Spill kit observed onsite.

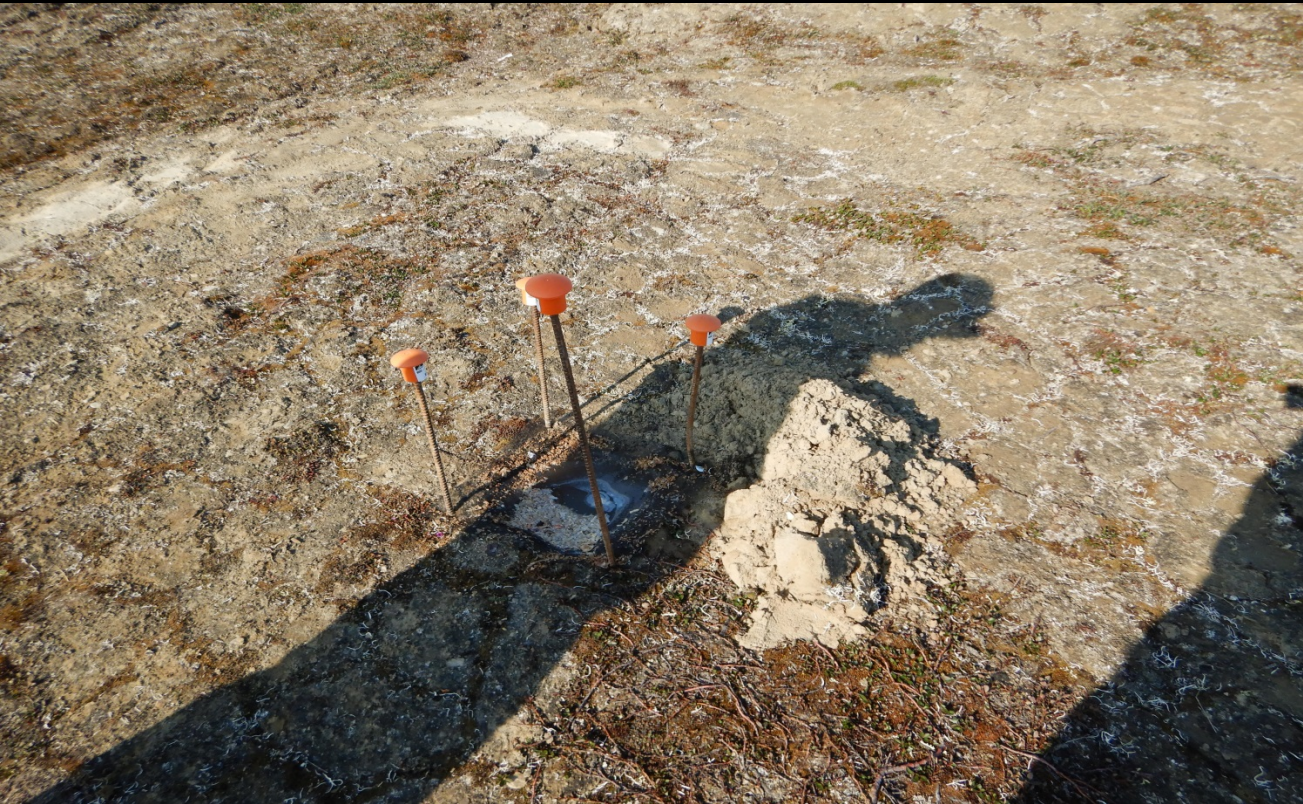
Photo 7

3. Sump pit observed on site. The sump pit was very small and clearly marked and more than 31 metres away from any water body.
4. Grey water discharge levels measured and recorded in log book and observed onsite (photo). Log Book records indicate that between the dates of May 31, 2019 and July 7, 2019 a total of 316 litres of grey water deposited into the sump pit(photo)
5. No latrine observed on site
6. No sign of fire pits

Description: sump pit
