CANADIAN
NORTH
RESOURCES INC.

Ferguson Lake Project

Abandonment and Restoration Plan, 2021

November 2021

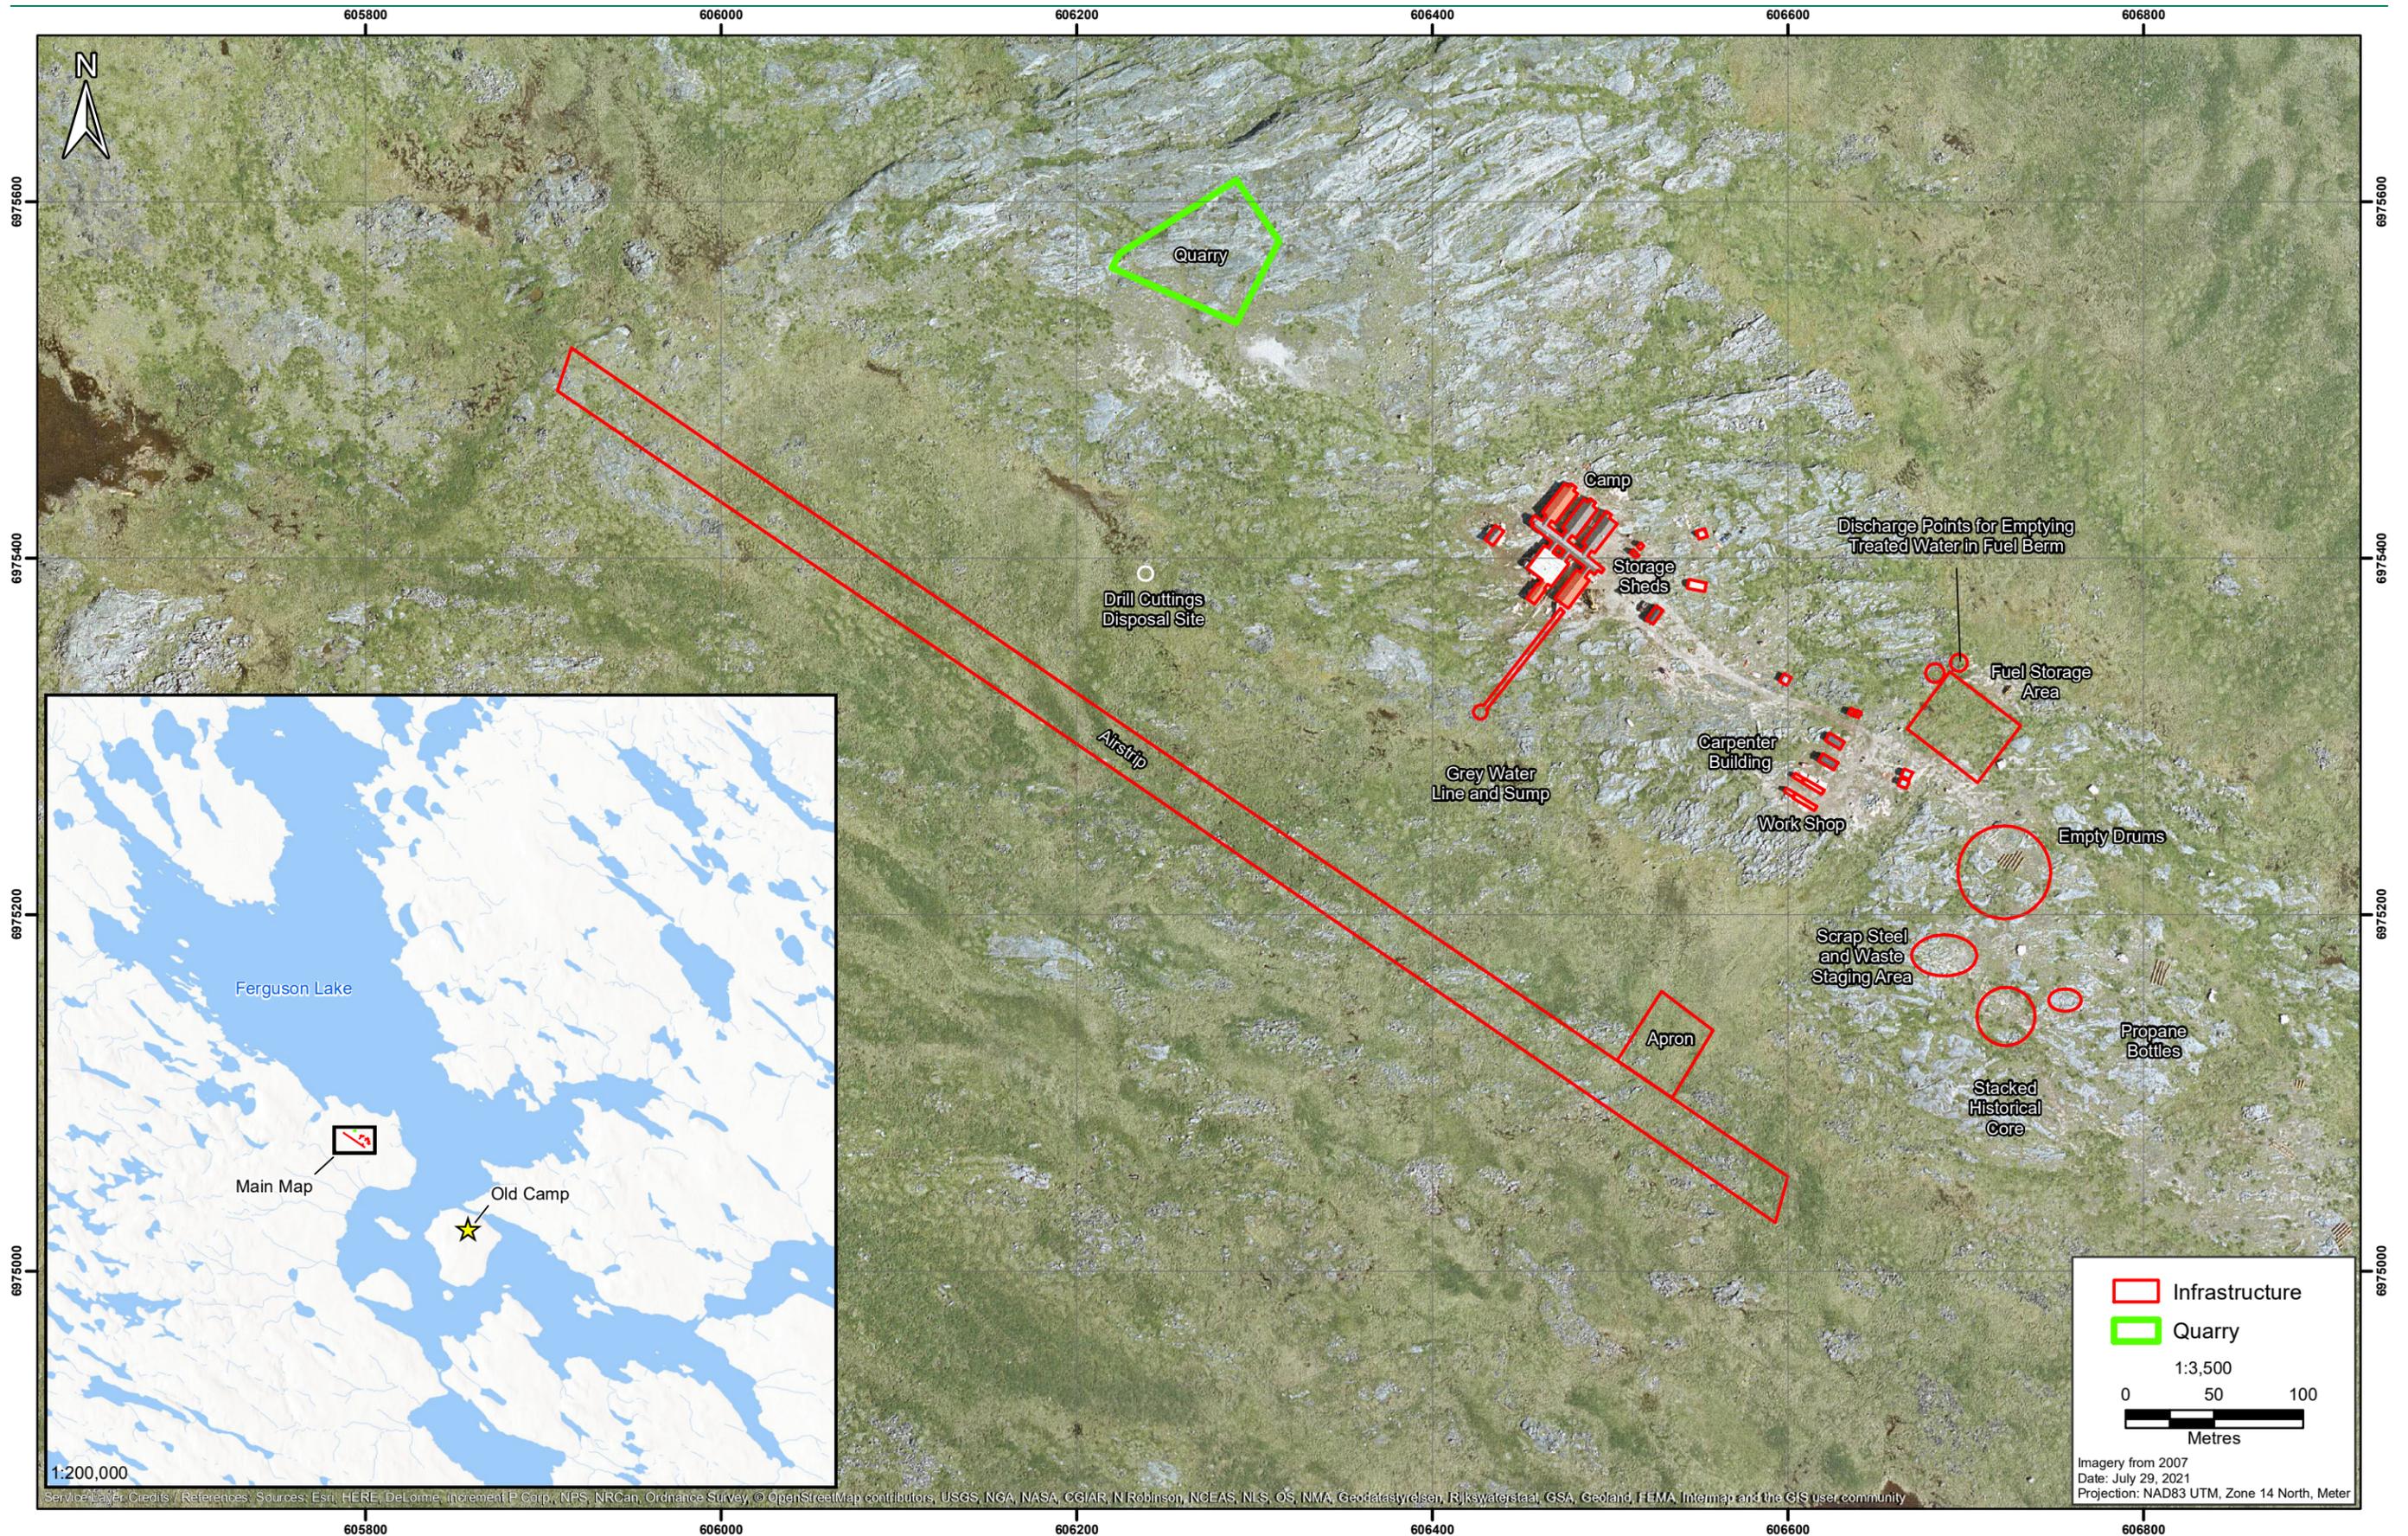
Figure 2: Ferguson Lake Camp

The “new” or current camp site and core storage area are located near the southwest shore of Ferguson Lake (Figure 2). The site is situated on a low ridge at an elevation between 120 m and 130 m and is within a level area of low bedrock outcrops, sand, and gravel. The nearest water body is a small pond about 300 m south of the camp site. This pond drains to another pond and eventually south to Ferguson Lake.

The airstrip is located approximately 200 m southwest of the camp, a site selected in coordination with the KIA (Figure 2). The airstrip was designed to accommodate aircraft adequate to support future exploration work (i.e., Twin Otter, Dash 8, and DHC-5 Buffalo sized aircraft). The airstrip is gravel surface airstrip of approximately 800 m x 25 m with an aircraft apron to accommodate maintenance equipment storage, and cargo storage.

The location of all historical drill sites is presented in Figure 1 and the drill cuttings disposal site is indicated in Figure 2.

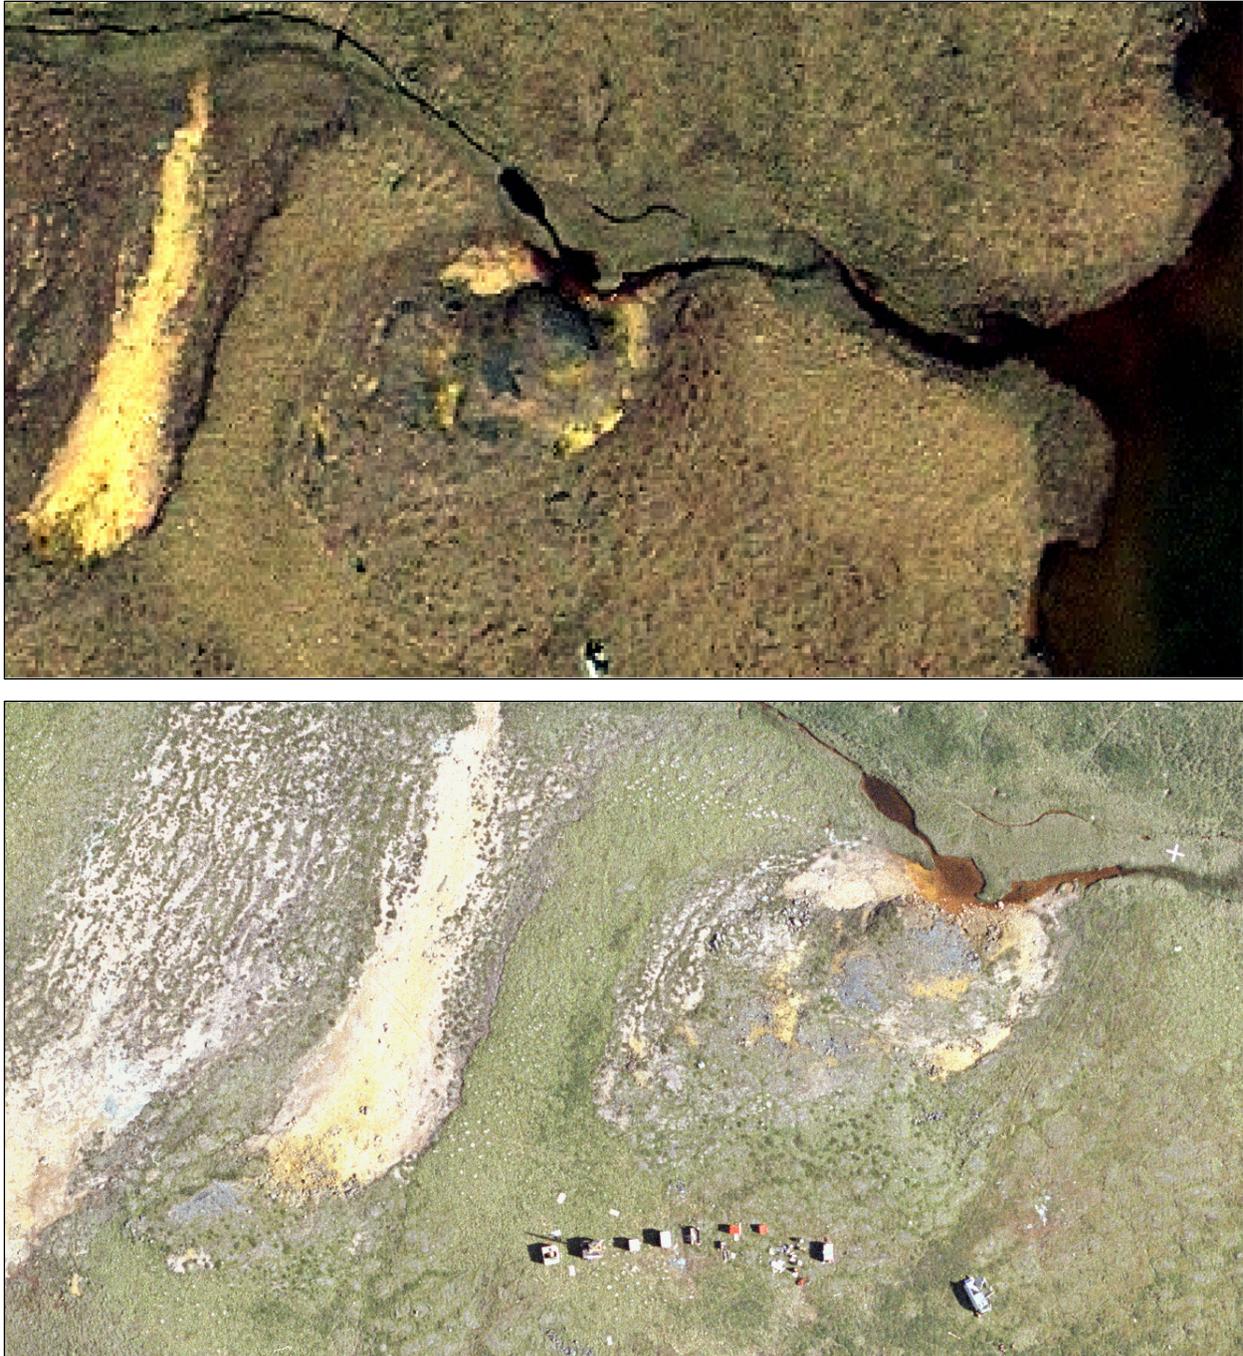
Figure 3: Ferguson Lake Drill Staging Area before Staging in 2005 (top) and after Staging in 2008 (bottom)

A Water Licence inspection (on August 21, 2014) of a drill staging area located at N 62° 52' 9.768" W 96° 55' 29 7.48 noted erosion and weathering of the area (see Water Licence condition 2c). The inspector noted that the area had become red and has been eroding progressively over the last three years. As a requirement of Water Licence condition 2c, preventative erosion measures implemented in the area should be documented in this Abandonment and Restoration Plan. However, the erosion identified by the inspector is a natural acid water gossan caused by the intersection of the Ferguson Lake Ni-Cu-PGE massive sulphide deposit at the surface which extends east-west intermittently for kilometres on both sides of the lake and was the original exploration indicator of mineralization on the property (Figure 3). The area was sampled and leveled afterwards but remains gossanous similar to the other sites of natural acid water weathering over the deposit. This description and results of sampling was submitted in 2015 and no additional action was requested. CNRI can continue discussions with CIRNAC if required.

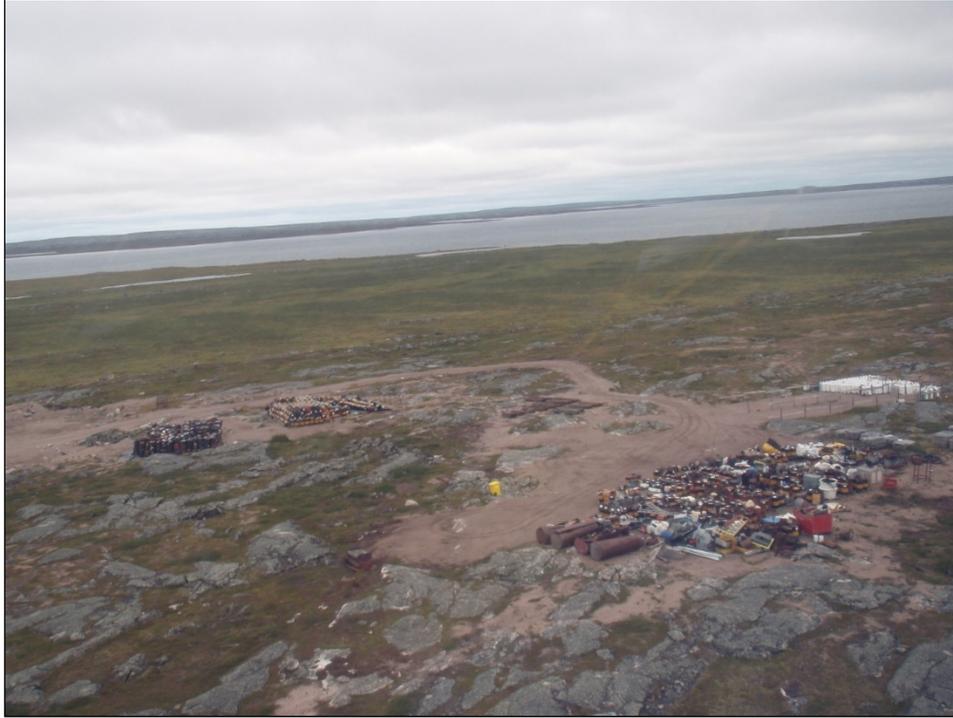
Photo 1: Ferguson Lake Camp waste pile prior to initiation of remediation work.

CNRI is undertaking ongoing remediation and restoration at the Ferguson Lake camp and operations area, with a focus on the management of the stored waste debris and scrap metal that was cleared from the old camp and laydown area (Photo 1). The camp was re-opened from June 21 to September 20, 2021, during which major repair and maintenance was completed on the camp buildings, equipment, and airstrip.

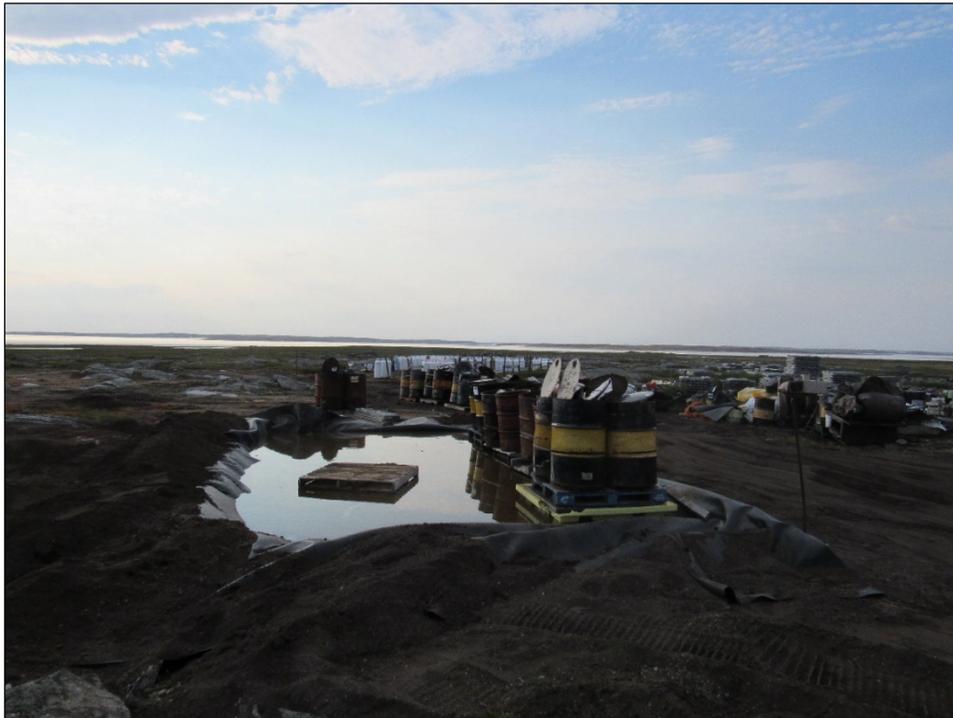
Photo 2: Temporary lined berm for containment of waters from waste drums.

Between June and September, 2021, a multi-stage program was initiated to deal with the stored waste. The program entailed the installation of a temporary lined containment berm by the pile for the draining of waters in those prioritized drums filled with suspected hazardous soil and garbage originally from the old camp as shown in Photo 2.

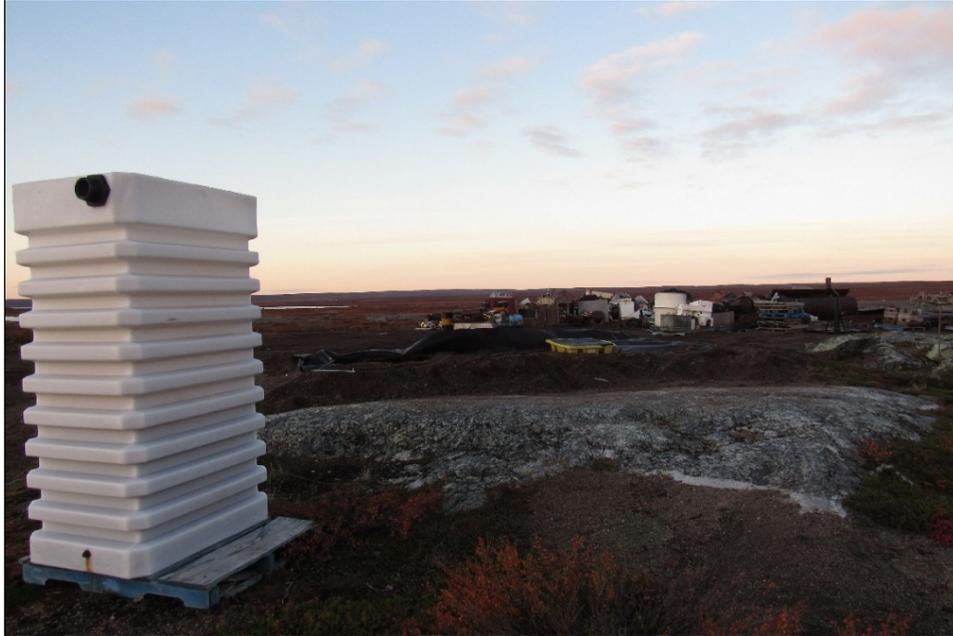
Photo 3: Plastic tank used for containment of excess waters from berm.

As the water level rose in the temporary berm, excess waters were pumped into a plastic tank as shown in Photo 3. No significant indications of the presence of hydrocarbons were observed on the surface of the berm waters or in the tank.

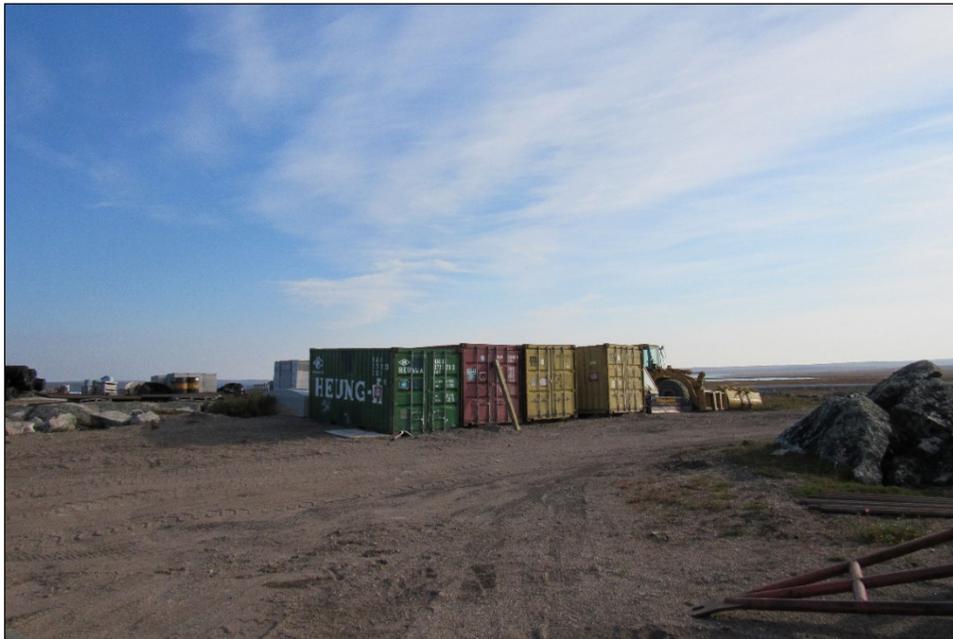
Photo 4: Containers loaded with waste-filled drums ready for overland winter haul.

The waste-filled, but now dry, drums were then loaded in the four lined containers in preparation for being hauled out overland to Baker Lake as shown in Photo 4.

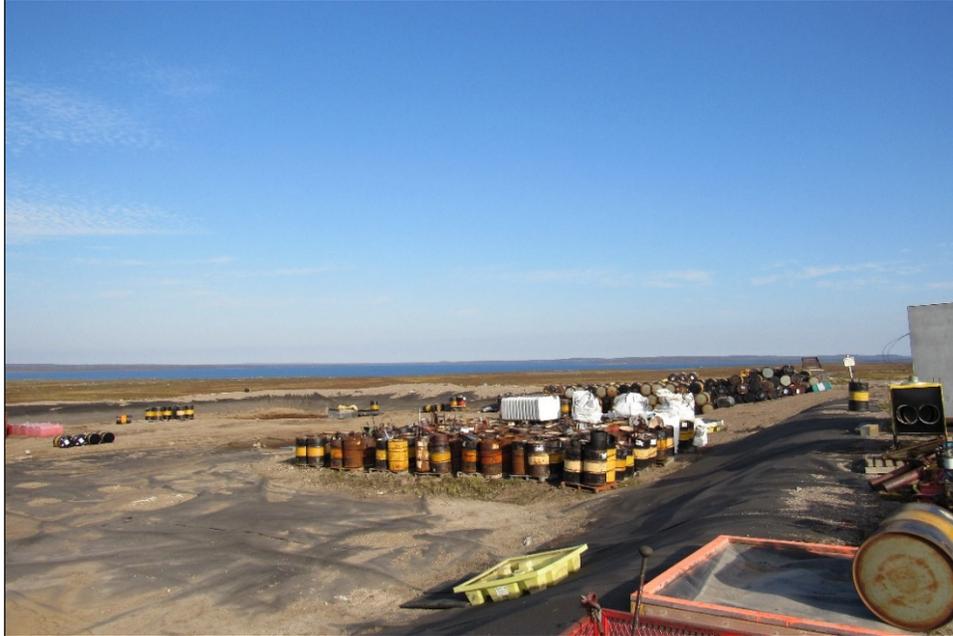
Photo 5: Main lined berm containing excess, now dry, waste-filled drums.

Once the containers were filled, excess soil and garbage-filled drums were stored in the main berm as in Photo 5.

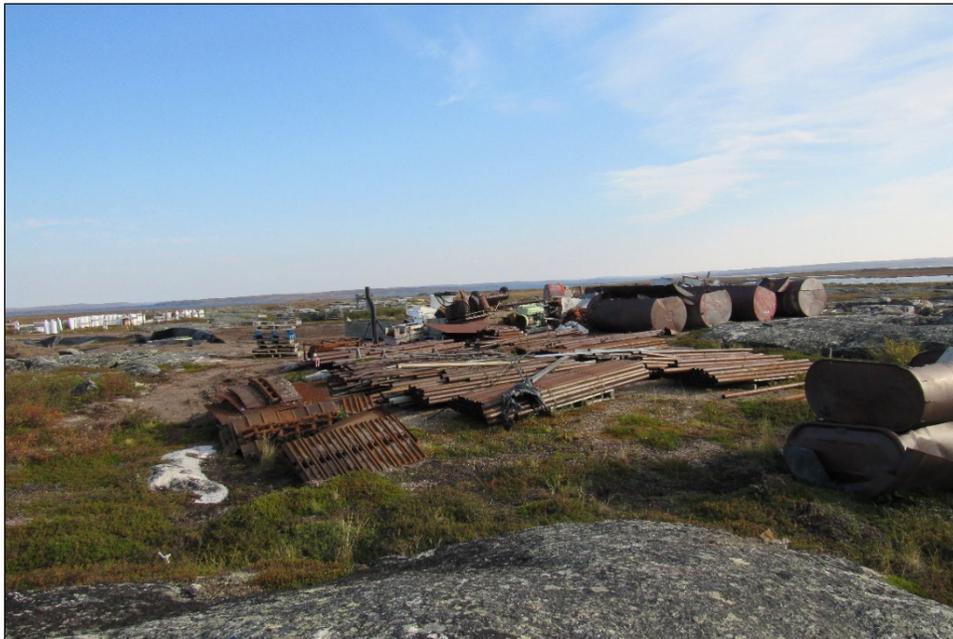
Photo 6: Remaining scrap steel and plastic debris in waste pile.

Additional empty containers will need to be hauled into the camp to be filled with this excess material and then all will be hauled out together to be barged out the following summer from Baker Lake to an accredited disposal site in southern Canada. Scrap steel with some plastic debris remain at the waste dump to be sold as salvage or disposed at a municipal dump with permission of local authorities as shown in Photo 6.
